DEPARTMENT OF THE ARMY
 US ARMY INSTALLATION MANAGEMENT COMMAND, PACIFIC REGION
 HEADQUARTERS, UNITED STATES ARMY GARRISON, HAWAII
 SCHOFIELD BARRACKS, HAWAII 96857-5000

Periodic Progress Report dated October 1, 2007

2.4 Kahuku Training Area (KTA) Following is a description of work that has been completed and/or is on-going at KTA since June 16, 2007. These locations are identified on KTA map at Attachment 1.

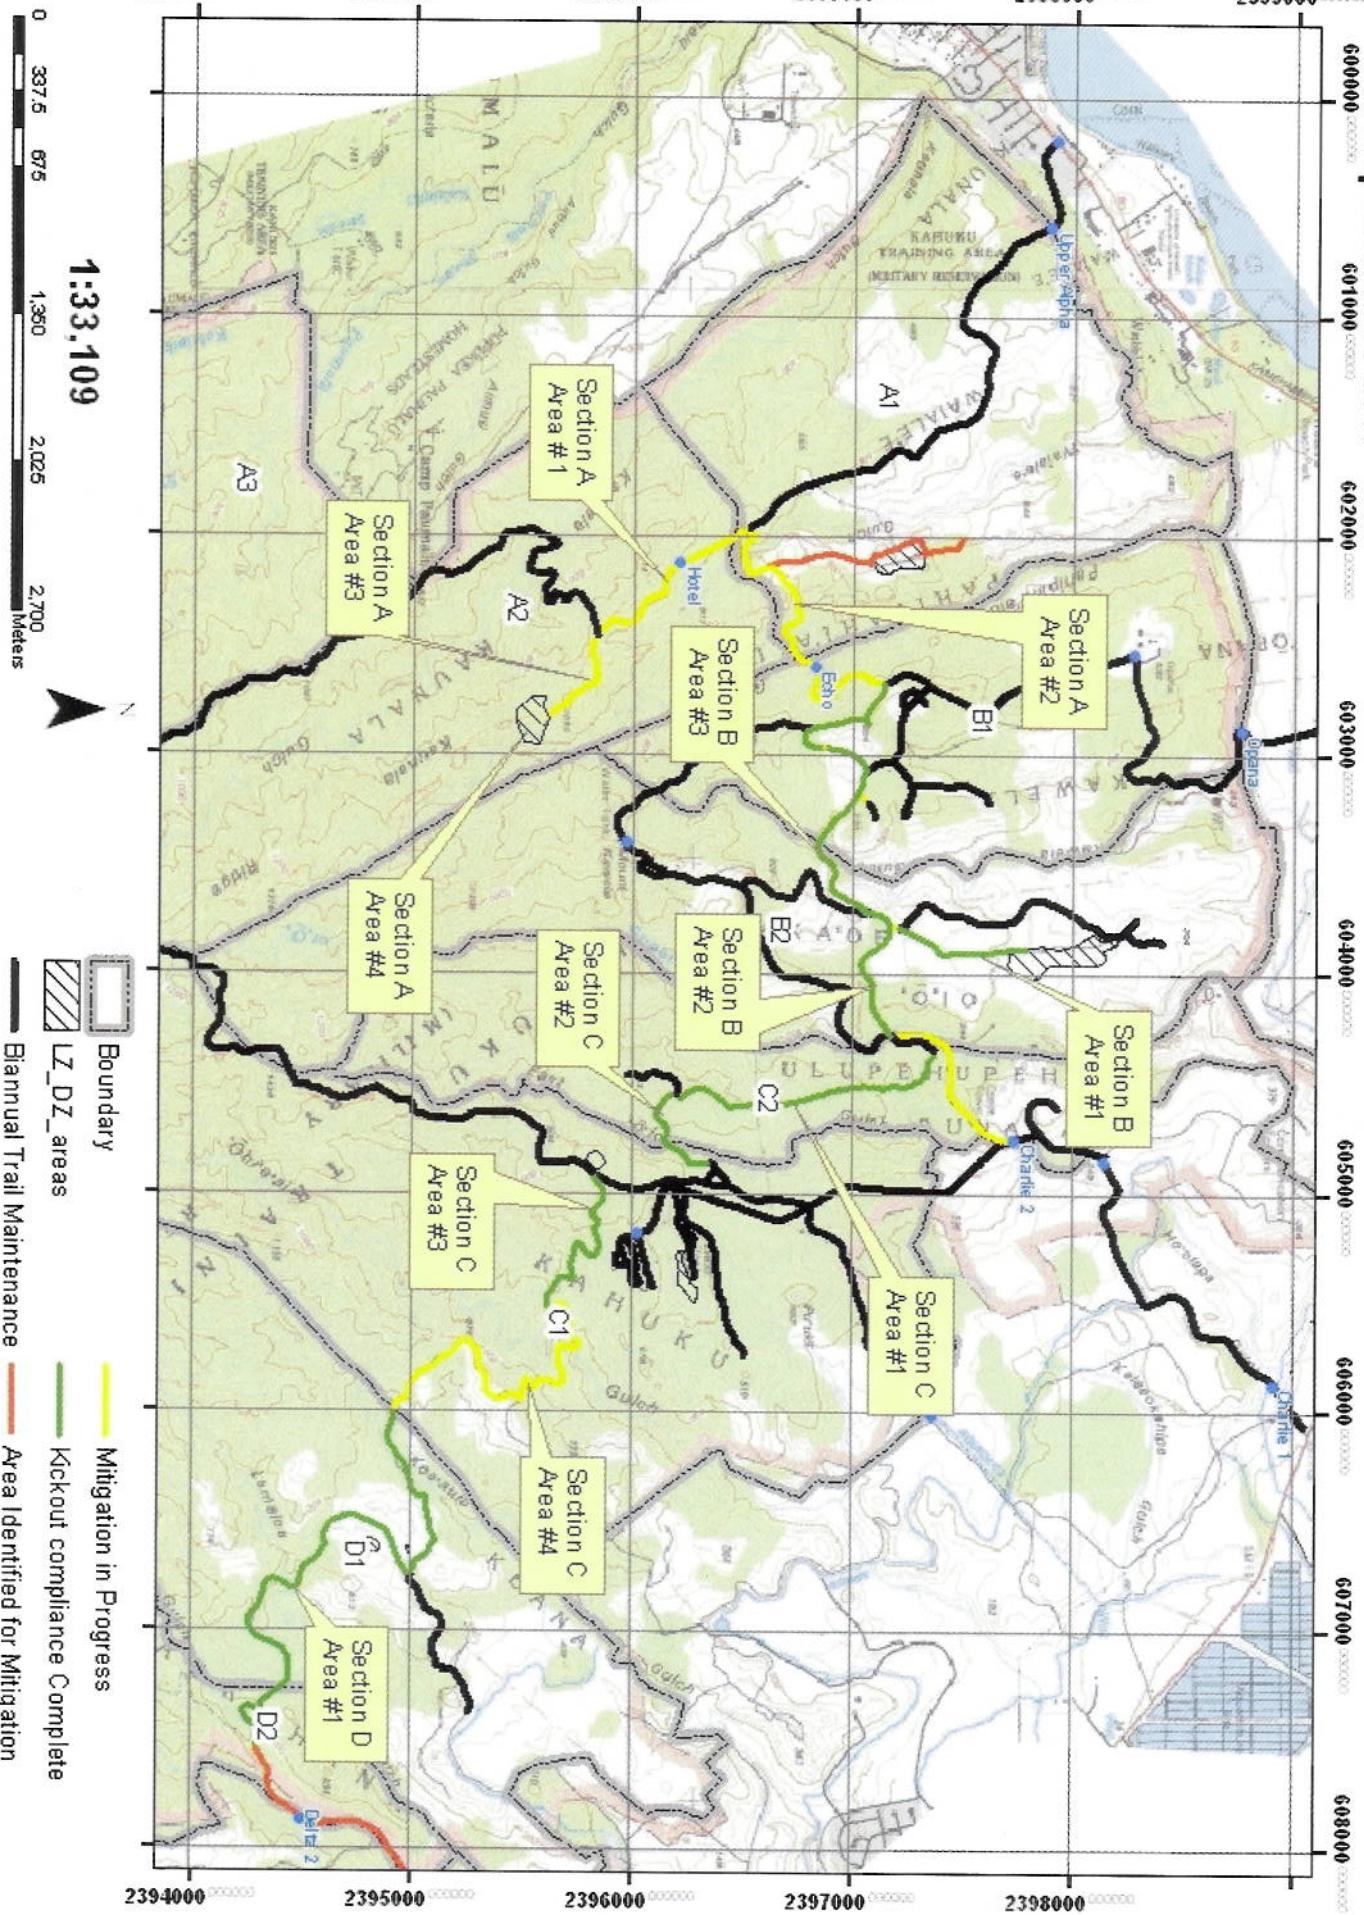
Figure 1

Kahuuku Range Court Compliance Prepared By ITAM/GIS
